DEPARTMENT OF TRANSPORTATION

Quality Assurance and Source Inspection

Contract #: 04-0120F4Cty: SF/ALA Rte: 80 PM: 13.2/13.9File #: 99.28**WELDING INSPECTION REPORT****Resident Engineer:**Siegenthaler, Peter**Address:** 333 Burma Road**City:** Oakland, CA 94607**Report No:** WIR-021472**Date Inspected:** 22-Nov-2010**Project Name:** SAS Superstructure**OSM Arrival Time:** 700**Prime Contractor:** American Bridge/Fluor Enterprises, a JV**OSM Departure Time:** 1900**Contractor:** Zhenhua Port Machinery Company, Ltd (ZPMC) Chanxing Island**Location:** Shanghai, China

Bridge No: 34-0006**Component:** OBG Segment**Summary of Items Observed:**

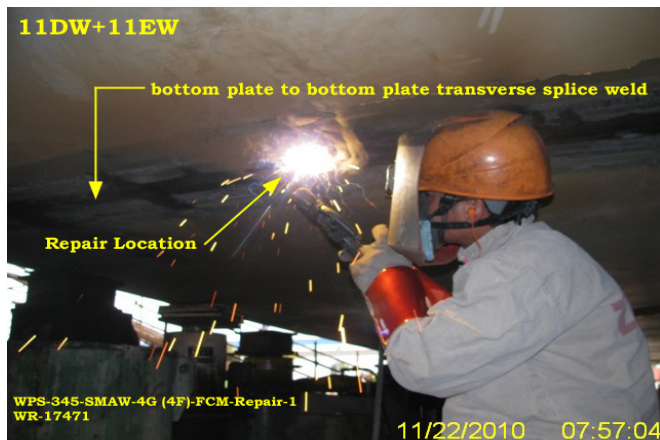
ZPMC welding personnel performing Shielded Metal Arc Welding (SMAW) of Repair weld for the bottom plate to bottom plate transverse splice weld joint located on 11DW+11EW. The weld is designated as OBW11C-008. The welder is identified as 046709. ZPMC QC Mr. WANG ZHU was onsite monitoring the welding variables.

The inprocess SMAW appears to be progressing in compliance with WPS-345-SMAW-4G (4F)-FCM-Repair-1. The weld repair report number is named as WR-17471. See the attached picture for weld detail.
